## THE OUTBURST OF BASHKARA GLACIER LAKE (CENTRAL CAUCASUS, RUSSIA) ON SEPTEMBER 1, 2017

The outburst of Bashkara Lake on September 1, 2017 reflects the current stage of glacier downwasting when the stable regime of lakes, debris complexes and glaciers is disturbed. We have estimated the parameters of the lake outburst, as well as threshold and trigger conditions using ground-based and aerial observations, satellite imagery analysis, and instrumental data obtained from a drone, an echo-sounder, an automatic weather station, and a water level datalogger. An abnormal shower with 100 mm of precipitation happened during a night from August 31 to September 1 following the previous (August 30–31) 45 mm rainfall, has been recognized as the trigger of the lake outburst. The volume of the liquid phase of the debris flood was about 1.1 mln m<sup>3</sup>, including water released during the lake outburst (0.8 mln m<sup>3</sup>). In the valley of the Adylsu River, the volume of 0.35–0.50 mln m<sup>3</sup> of debris was entrained into the flow. Based on this research, we propose recommendations on measures how to prevent emergencies which could take place in the area.

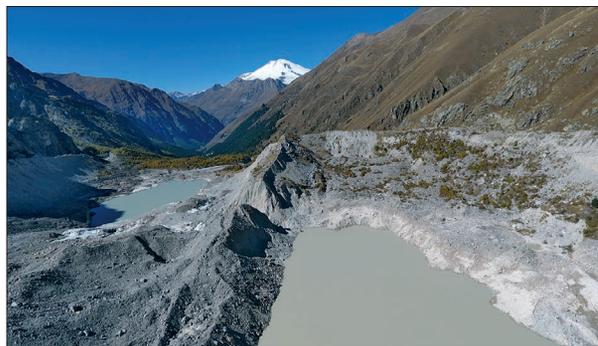
**Fig. 1. Bashkara Lake and Lapa Lake in Central Caucasus after the outburst of September 1, 2017.**

The quadrotor photo was provided by E.A. Savernyuk, 08.10.2017.

The flood was caused by the outburst of glacial Bashkara Lake (Fig. 1). The coordinates of the outburst place are 43°12'35" N and 42°43'28" E. In the late 1950s, the outbursts of Bashkara Lake resulted in destructive debris flows in the valley of the Adylsu

Traces of an instant splash of water onto the glacier below (Fig. 1, 4, *d*) and the absence of any traces of terraces or of the stay of the interim water levels in the lake, which is observed in erosional destruction of the moraine dam (for example, [Chernomorets *et al.*, 2007b]) suggest the high degree of probability of such a scenario. The trapeziform configuration of the upper part of the cut, where the main volume of the lake water was discharged, also supports this hypothesis. As a result, after fast filling of the funnel near the

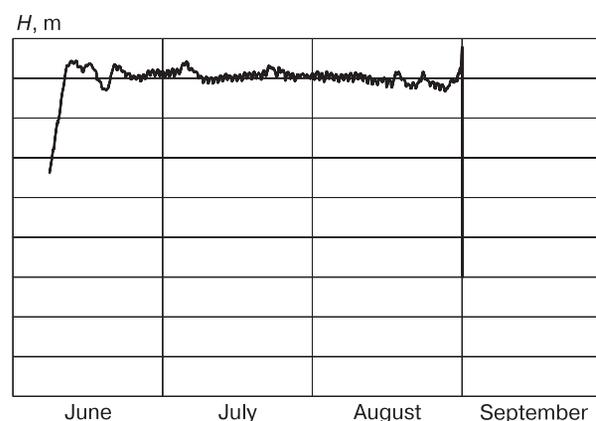
**Fig. 2. Variations in the water level in in Bashkara Lake in the summer of 2017.**

The horizontal lines are drawn every 1 m. After the outburst of 01.09.2017. The water level dropped by 16.5 m, but the level gauge recorded data only until it reached the surface.

lake until the outburst. In the lake, the water level was 55 cm higher on September 1, compared to August 31 at 20:00, and was 578 cm above the level gauge. In the period of direct observations, such fast growth of the water level had not been observed. By the following observation benchmark at 3 o'clock in the morning, the gauge level was already above the water level, i.e. at least 6-m discharge of water had already taken place (Fig. 2).

As a result of the outburst, the moraine dam was washed out, and by the morning of September 1, the water level had dropped by 16.5 m compared to the time before the outburst (Fig. 3), and the volume of water in the lake decreased by 3/4 (from 1 million  $m^3$  to 200 thousand  $m^3$ ). A catastrophic flood streamed down the Bashkara Glacier and further along the Adylsu Valley, in some areas turning into a debris flow. The roughly estimated inflow of water in the period of the anomalous shower (the lake's catchment basin is about 3.8  $km^2$ , the total precipitation is 100 mm, and the runoff coefficient is 0.6) could reach 200 thousand  $m^3$ . At least the volume of 50 thousand  $m^3$  of water was drawn into the flood during the outflow of water from Lapa Lake located near the lower end of the Bashkara Glacier (the mirror area of

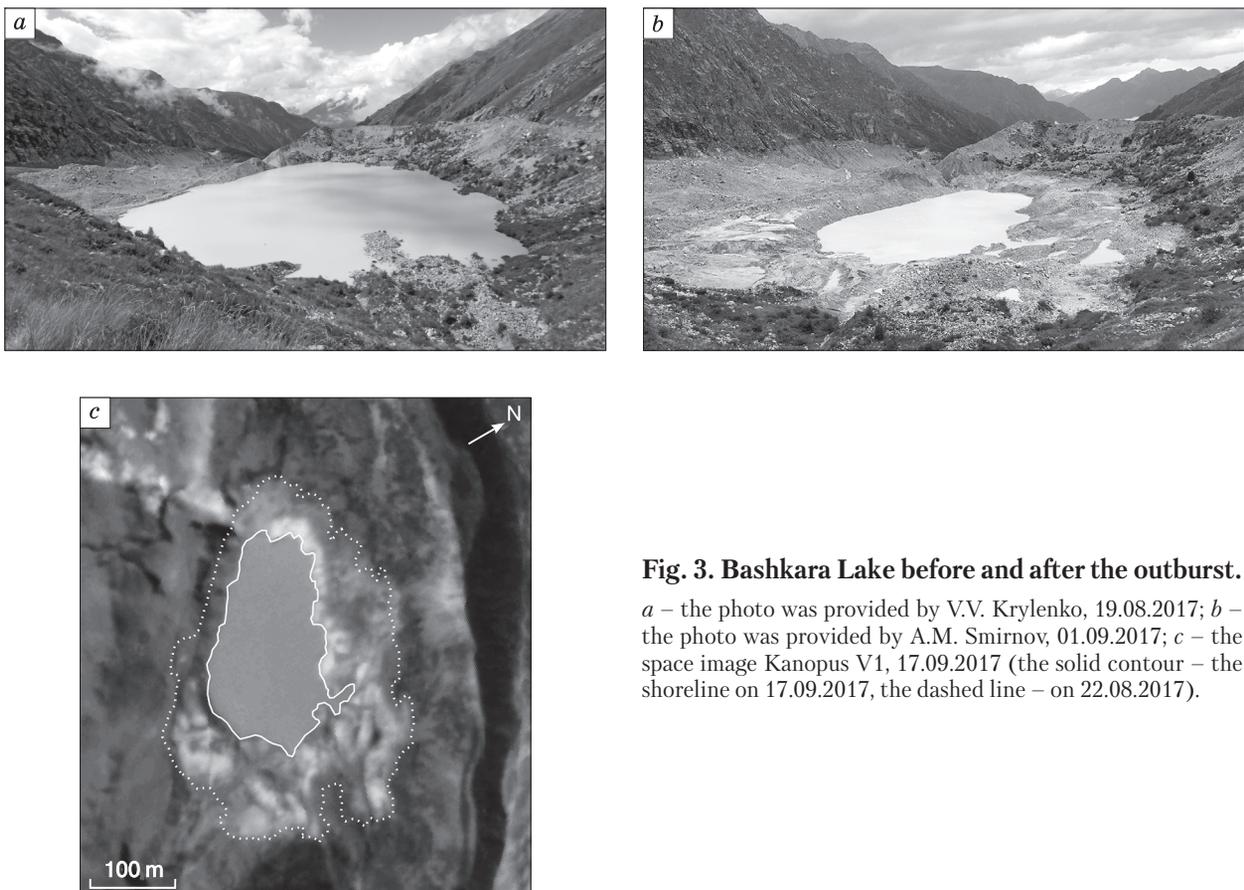
**Fig. 3. Bashkara Lake before and after the outburst.**

*a* – the photo was provided by V.V. Krylenko, 19.08.2017; *b* – the photo was provided by A.M. Smirnov, 01.09.2017; *c* – the space image Kanopus V1, 17.09.2017 (the solid contour – the shoreline on 17.09.2017, the dashed line – on 22.08.2017).

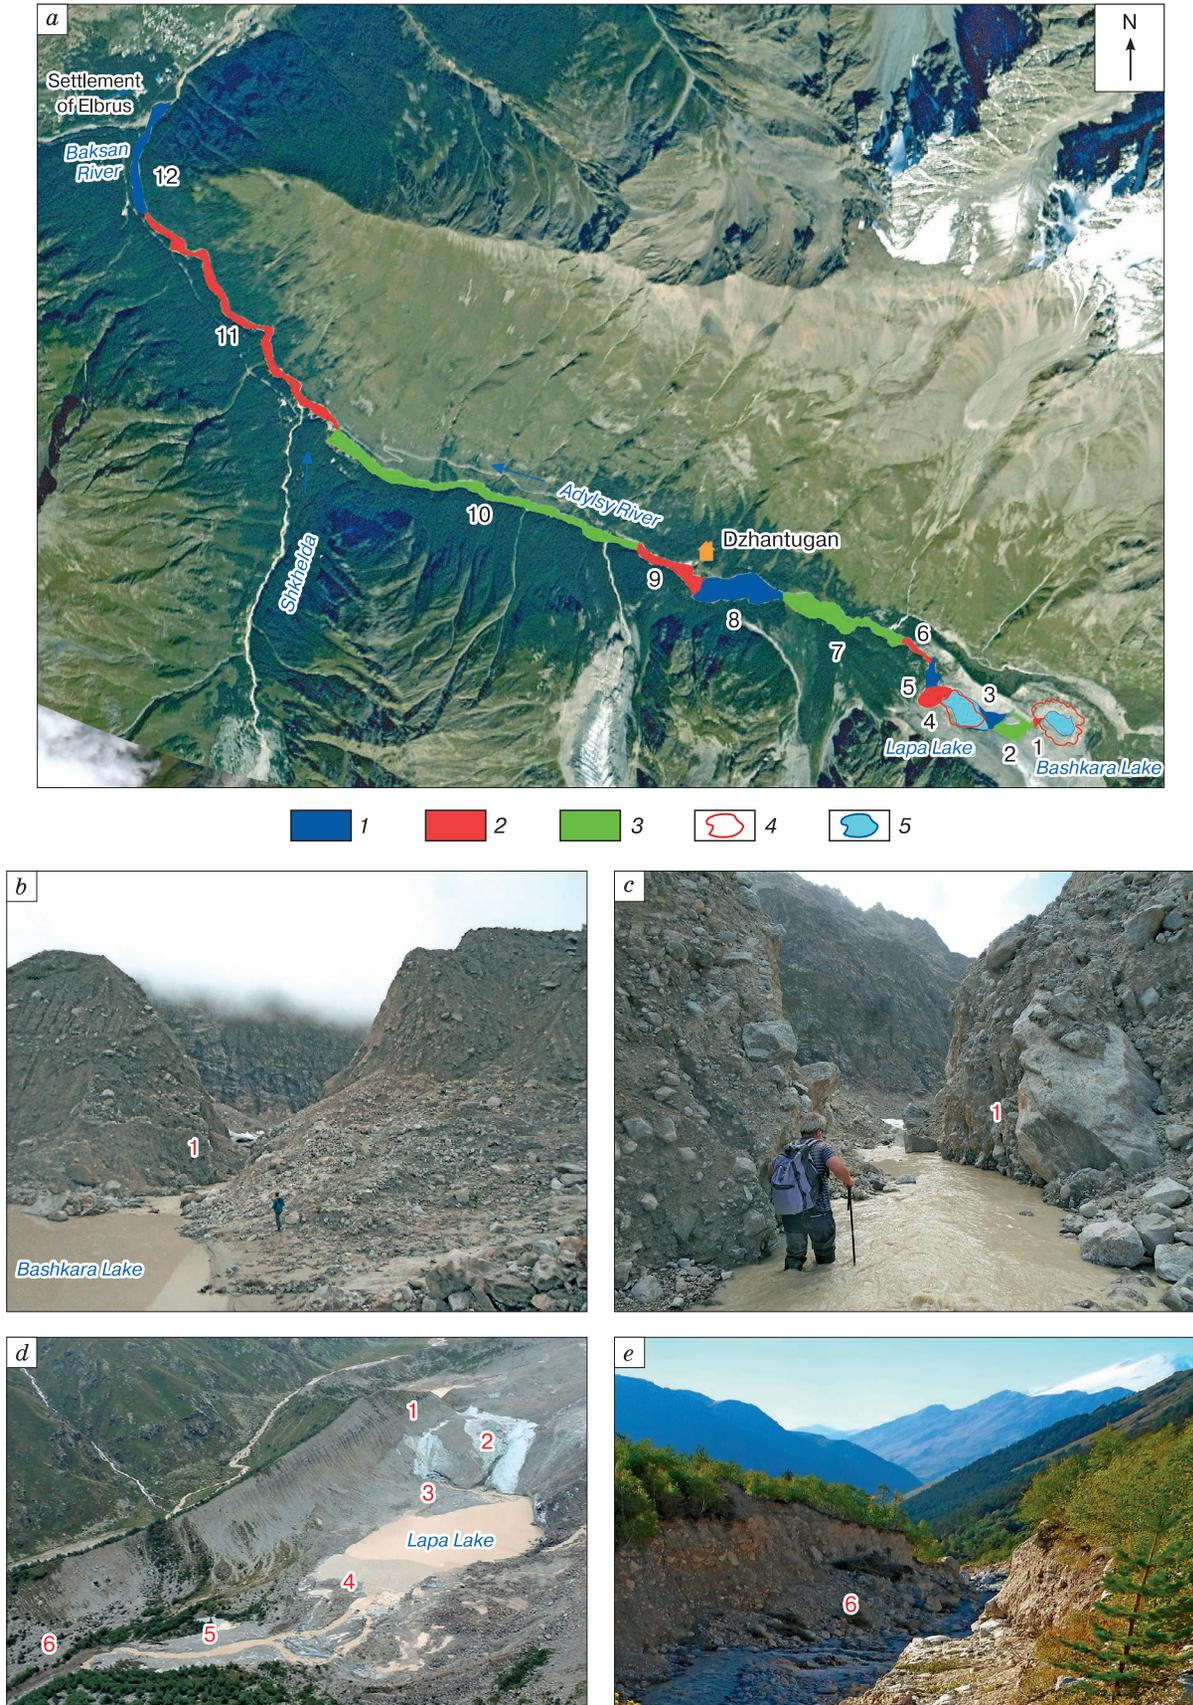
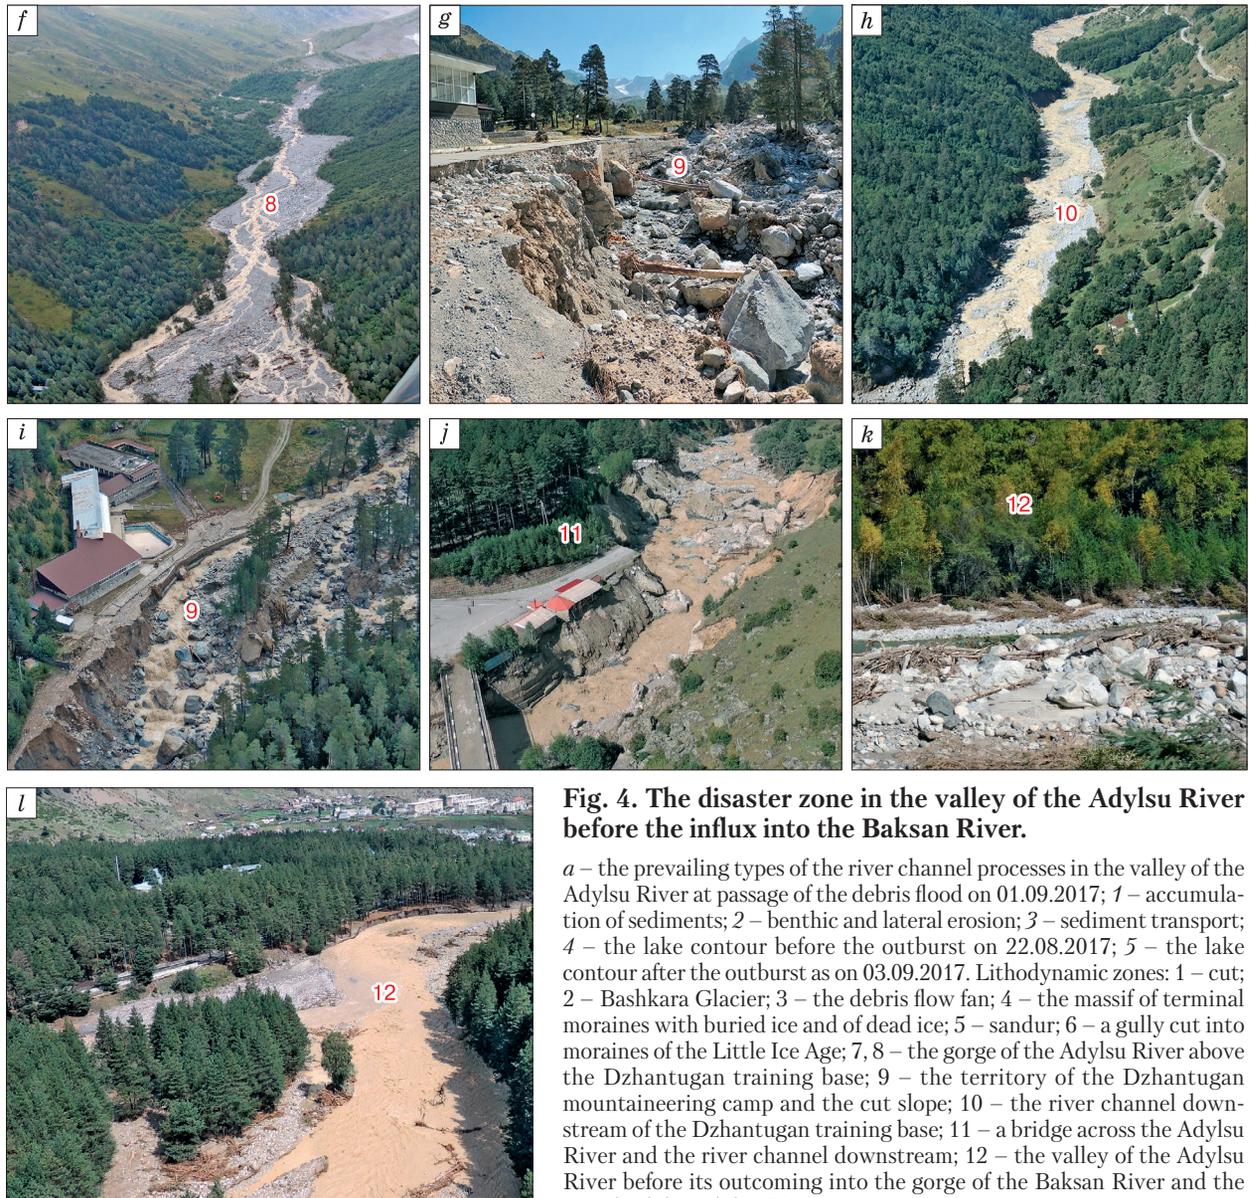
**Fig. 4. The disaster zone in the valley of the Adylsu River before the influx into the Baksan River.**

*a* – the prevailing types of the river channel processes in the valley of the Adylsu River at passage of the debris flood on 01.09.2017; 1 – accumulation of sediments; 2 – benthic and lateral erosion; 3 – sediment transport; 4 – the lake contour before the outburst on 22.08.2017; 5 – the lake contour after the outburst as on 03.09.2017. Lithodynamic zones: 1 – cut; 2 – Bashkara Glacier; 3 – the debris flow fan; 4 – the massif of terminal moraines with buried ice and of dead ice; 5 – sandur; 6 – a gully cut into moraines of the Little Ice Age; 7, 8 – the gorge of the Adylsu River above the Dzhantugan training base; 9 – the territory of the Dzhantugan mountaineering camp and the cut slope; 10 – the river channel downstream of the Dzhantugan training base; 11 – a bridge across the Adylsu River and the river channel downstream; 12 – the valley of the Adylsu River before its outcoming into the gorge of the Baksan River and the mouth of the Adylsu River.

The diagram was made by V.M. Kidyayeva. The base: a photo from the International Space Station (the photo was provided by S.N. Ryazansky, 03.09.2017). *b–l* – photo illustrations for the diagram (the numbers of the lithodynamic zones are provided in red in the photos). The photos were provided by: *b* – I.V. Krylenko, 03.09.2017; *c* – V.M. Kidyayeva, 03.09.2017; *d–j, l* – M.D. Dokukin, 01.09.2017; *k* – S.S. Chernomorets, 07.10.2017.

servation, analysis of photographs taken onboard the helicopter during the flyover immediately after the outburst and of space photographs taken onboard the international space station. The indicated lithodynamic zones are shown in Fig. 4.

According to the preliminary estimates, the volume of the debris involved into the outburst flood was 350–500 thousand  $m^3$ . The major mass of the debris was delivered into the flow due to lateral erosion in section 11 downstream from the bridge across the Adylsu River (200–300 thousand  $m^3$ , Fig. 4, *j*) and in section 9 downstream from the Dzhantugan sports base (100–150 thousand  $m^3$ , Fig. 4, *g, i*). Rather short sections of involvement of the solid material with prevalent bottom erosion section 1 (a cut, 20 thousand  $m^3$ , Fig. 4, *b, c*), section 4 (the frontal terrace of the moraine downstream from Lapa Lake, 20 thousand  $m^3$ , Fig. 4, *d*) and section 6 (the canyon covered by moraines of the Little Ice Age, 20 thousand  $m^3$ , Fig. 4, *e*) are located in the upstream part of the valley. The erosion sections are followed by the sections of debris accumulation or its transport and subsequent accumulation (Fig. 4, *f, h, k, l*).

raine (Fig. 4, *b, c*). Falling off of large lumps of ground from the walls of the cut (new material up to 30 m<sup>3</sup> was found) is hazardous, as it may cause rise of backwater in the lake, followed by washout of the dam pool. The possible rise of the water level may be decimeters—the first meters, the outburst flood during the washout would be insignificant and is likely to fully pass through the subglacial/intraglacial flow channel, performing the role of a regulator.

**Lapa Lake.** The dam pond of Lapa Lake was formed by several terminal moraines containing buried ice. After the outburst, the lake water level remained to be approximately 1 m lower than the level in the pre-flood period, was well recorded by abrasion scarps on sandy beaches and by the thermal abrasion niche in the vertical cliffs of the ice banks. The overflow started as a wide flat flow of water, 60 m below there are steep spillways 3–4 m high. Below the spillways, the branches cut into a mass of dead ice 60 × 100 m in size, denudated by the outburst flood, to the depth of 3–5 m (Fig. 4).

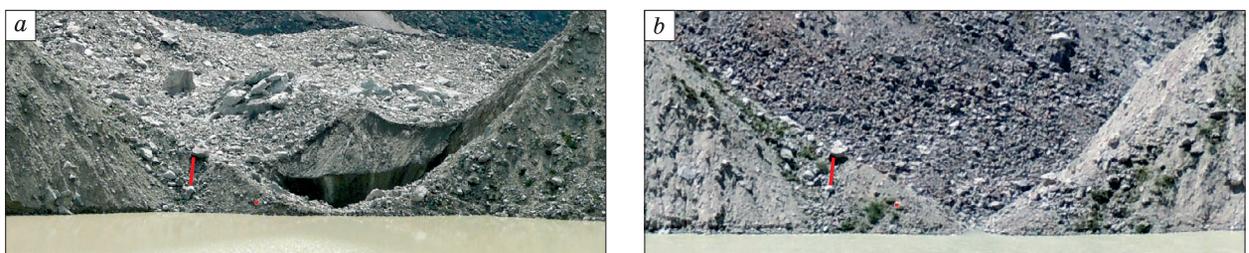
**Fig. 5. Part of a morainic dam, Bashkara Lake, in 2008 and in 2017.**

*a* – 16.07.2008; *b* – 28.07.2017. Lowering of the surface of Bashkara Glacier by more than 10 m. The red arrow illustrates the change in the position of rocks in relation to the maximum water level (*b*) compared to the level of 2008 (*a*). The photo was provided by M.D. Dokukin.

The surface of the Bashara Glacier, which propped up the dam in 2008, significantly decreased (Fig. 5). Retreat of the right branch of the glacier adjacent to Bashkara Lake on the front from 2009 to 2017 was 30–35 m, and that of the main flow of Bashkara Glacier adjacent to Lapa Lake from 2007 to 2017 was 100–105 m.

Decrease of the surface of Bashkara Glacier contributed to stability of the moraine dam. Whereas in 2008 it was backed by the glacier, this support has recently disappeared.

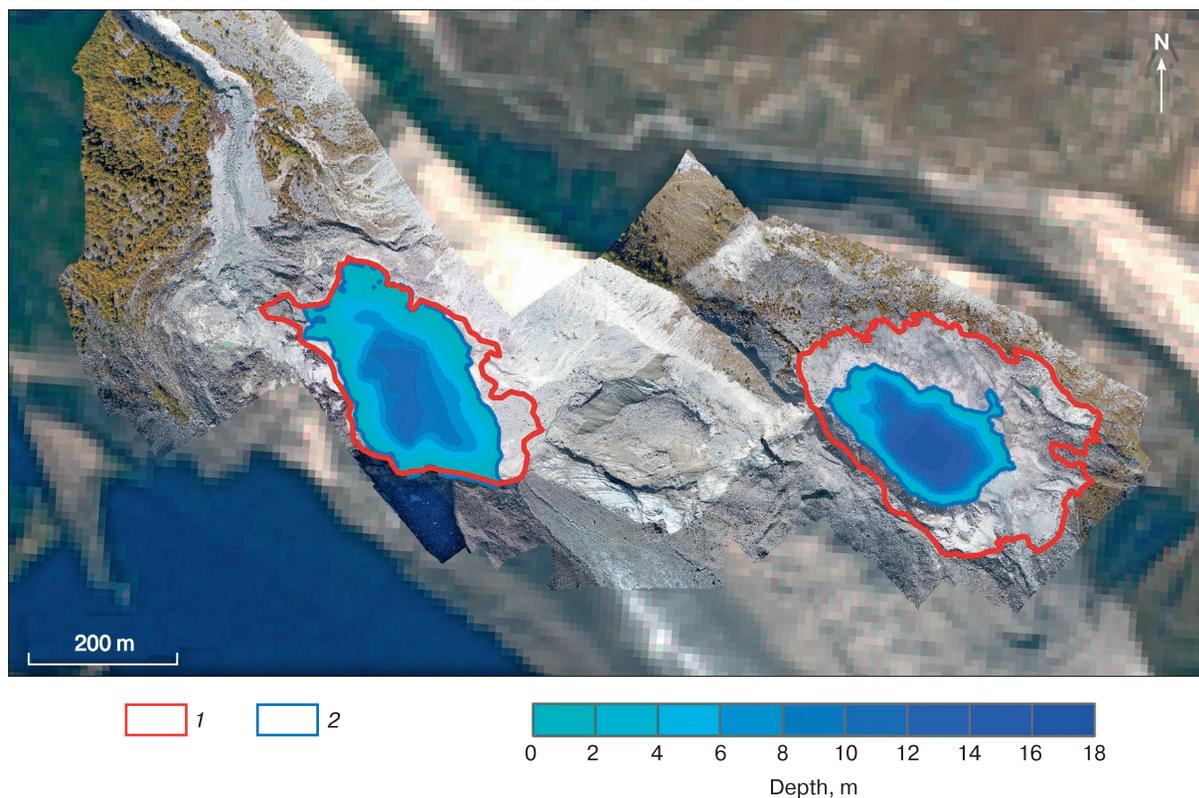
Fig. 6. Bathymetric maps of Bashkara Lake (*right*) and Lapa Lake (*left*) after the outburst.

The lake's contour: 1 – according to the space image Kanopus V1 as of 22.08.2017; 2 – according to the quadrotor survey of 08.10.2017. The base – a space image from Sentinel-2 as of 07.10.2017, the orthophoto is made of quadrotor images of 08.10.2017. The quadrotor survey and the bathymetric maps – E.A. Savernyuk, the orthophoto – A.I. Yarkova, E.A. Baldina.

In any case, erosion of the dam will take place in the shallow part of the lake (Fig. 6), and the possible discharge of water from the lake, without taking the incoming water into account, will not exceed 200 thousand m<sup>3</sup>.
